Proceedings of the 7th International Conference on Concrete Repair, Rehabilitation and Retrofitting

Non-destructive Testing of a Post-tensioned Concrete Road Bridge in Norway

Abstract. The Herøysunds bridge on the west-coast in Nordland Fylke in Norway had undergone concrete repair works with focus on reinforcement corrosion. During these actions, it was discovered that the tendon ducts had loss of injection.

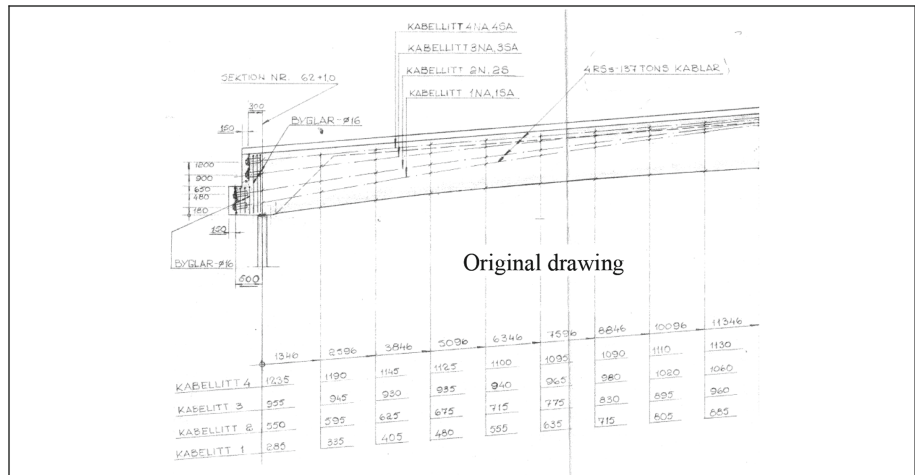
Fig. 3. Inspection of ducts in the north/south girder, Location A

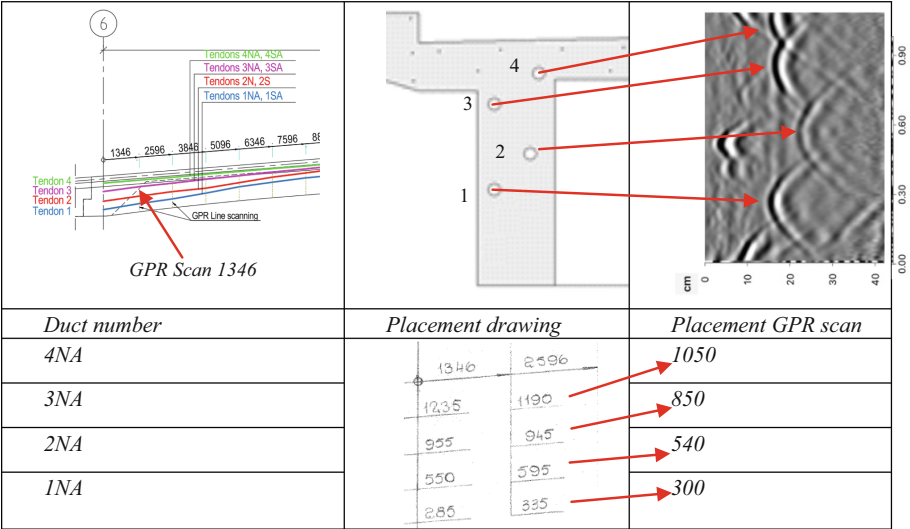
Fig. 4. Corroborating the GPR results with as-designed drawings showing the placement of tendon ducts in north girder and a comparison with the placement.

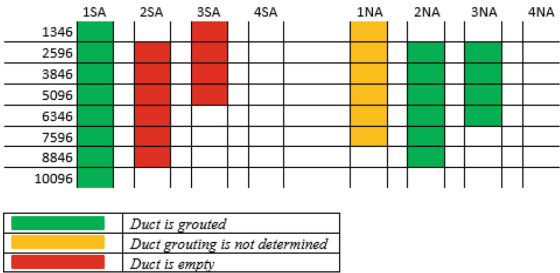
Inspection of tendon ducts started at the anchors placed in axis 6 in both north (N) and south (S) girder. The most severe locations were found on the south girder in tendon 2SA and 3SA. In the south girder two of the ducts was completely empty and had severe corrosion on the tendons. In the north girder duct 1NA gave indications to be lacking grout, the verification showed no presence of voids. Figure 6 shows a simplified overview of the scans and the ultrasonic results is shown in Fig. 7.

Fig. 6. Grouting status according to Ultrasonic results

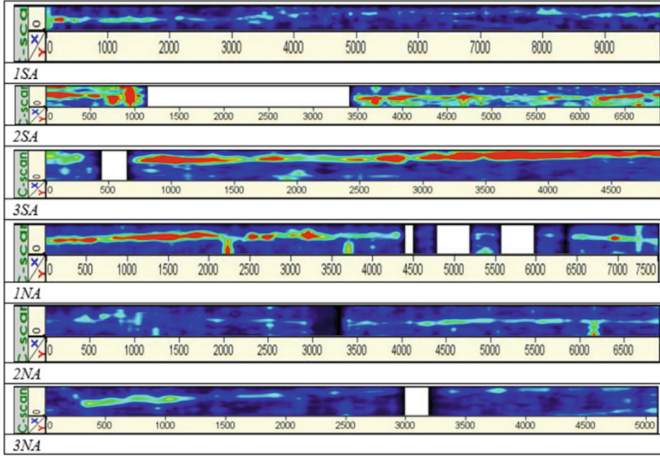
Fig. 7. Ultrasonic results in south and north girder

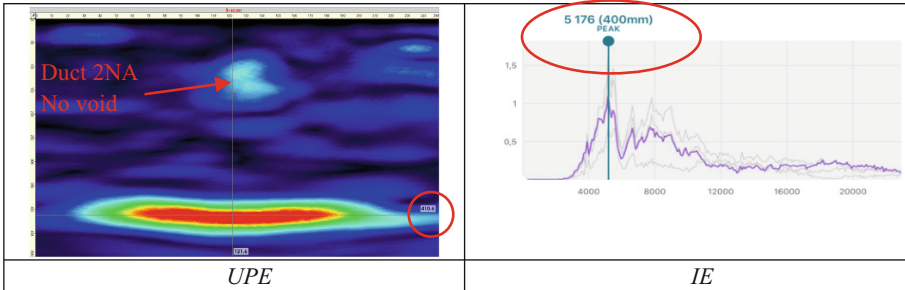
The frequency peak we should look for is 5,176 kHz and if we get a peak at this frequency Impact echo shows that no voids is presence in the inspected duct 2NA, see Fig. 8.

Fig. 8. Scan in 2NA scan 67 with no presence of voids. Backwall at 400 with both UPE & IE.

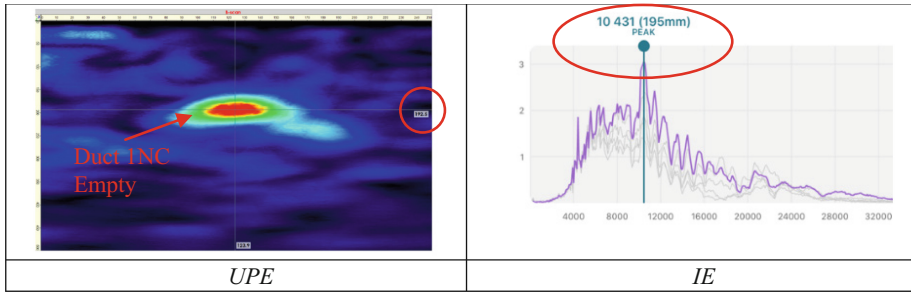
Figure 9 shows a scan of a duct with a void, 1NC. In this example the duct is placed with a cover of $T = 190$ mm and $C_p = 4140$ m/s, a void in this duct should give a frequency peak according to the following calculation:

Fig. 9. Scan in 2NA scan 67 with no presence of voids. Backwall at 400 with both UPE & IE.
