Non-destructive testing of a post-tensioned concrete road bridge in Norway

Abstract. The Herøysunds bridge on the west-coast in Nordland Fylke in Norway had undergone concrete repair works with focus on reinforcement corrosion. During these actions, it was discovered that the tendon ducts had loss of injection.

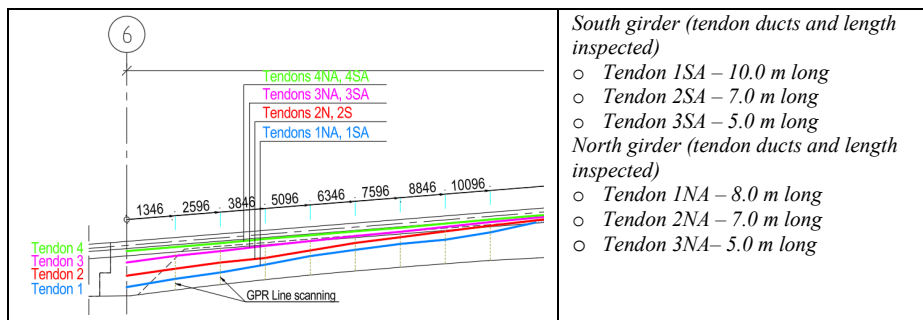
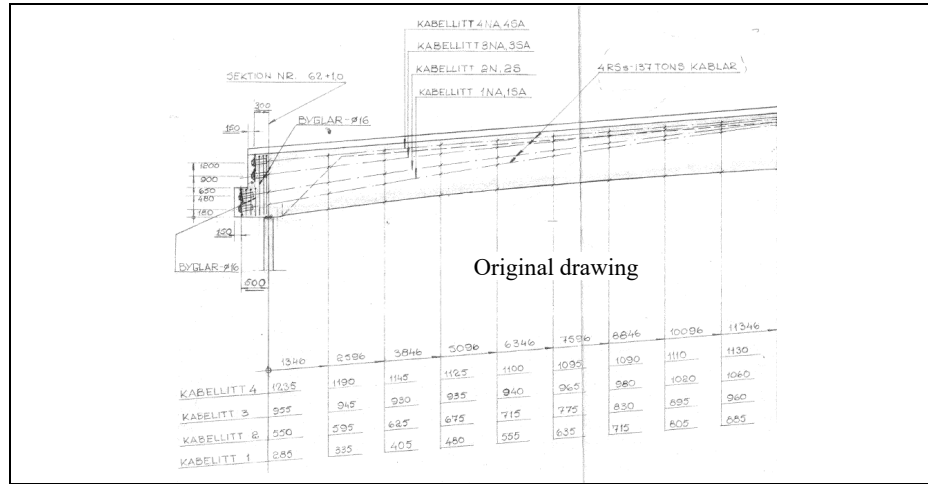
Fig. 3. Inspection of ducts in the north/south girder, Location A

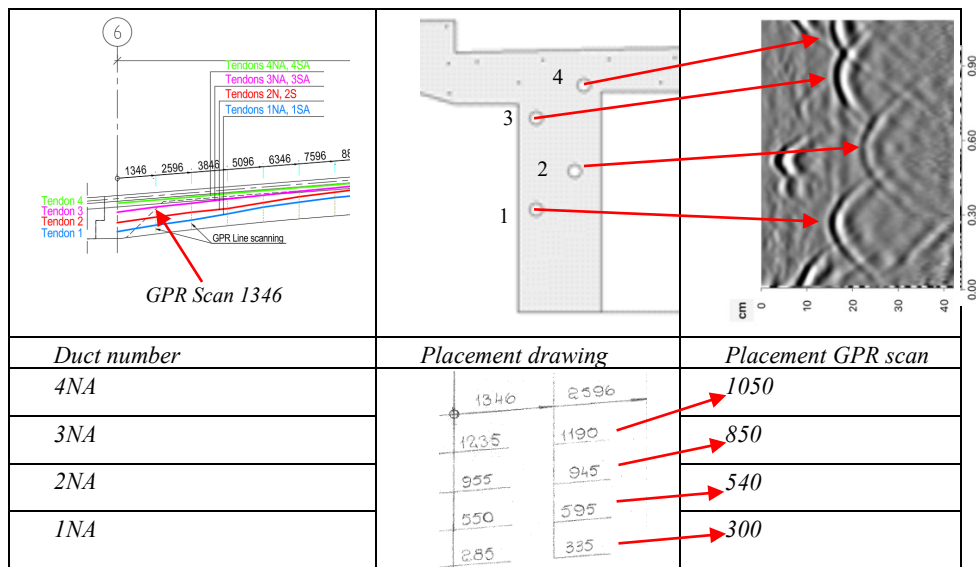
Fig. 4. Corroborating the GPR results with as-designed drawings showing the placement of tendon ducts in north girder and a comparison with the placement.

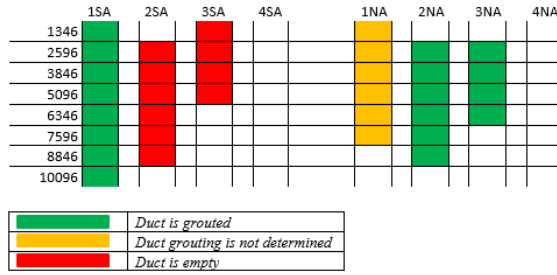
Inspection of tendon ducts started at the anchors placed in axis 6 in both north (N) and south (S) girder. The most severe locations were found on the south girder in tendon 2SA and 3SA. In the south girder two of the ducts was completely empty and had severe corrosion on the tendons. In the north girder duct 1NA gave indications to be lacking grout, the verification showed no presence of voids. Figure 6 shows a simplified overview of the scans and the ultrasonic results is shown in Figure 7.

Fig. 6. Grouting status according to Ultrasonic results

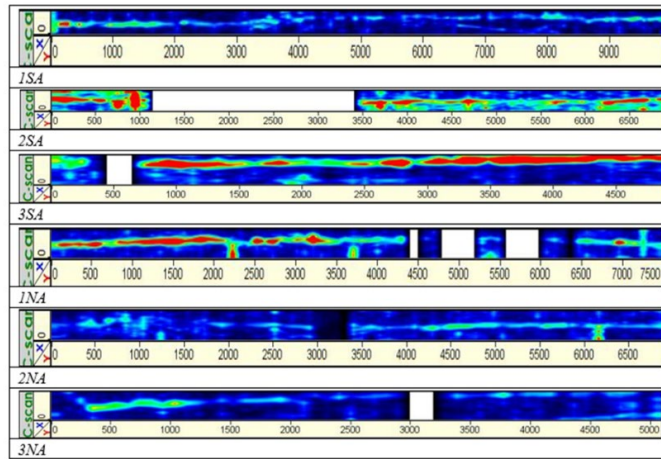
Fig. 7. Ultrasonic results in south and north girder

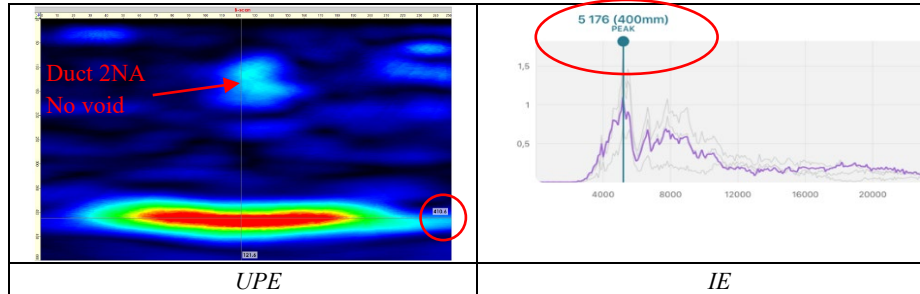
The frequency peak we should look for is 5,176kHz and if we get a peak at this frequency Impact echo shows that no voids is presence in the inspected duct 2NA, see figure 8.

Fig. 8. Scan in 2NA scan 67 with no presence of voids. Backwall at 400 with both UPE & IE.

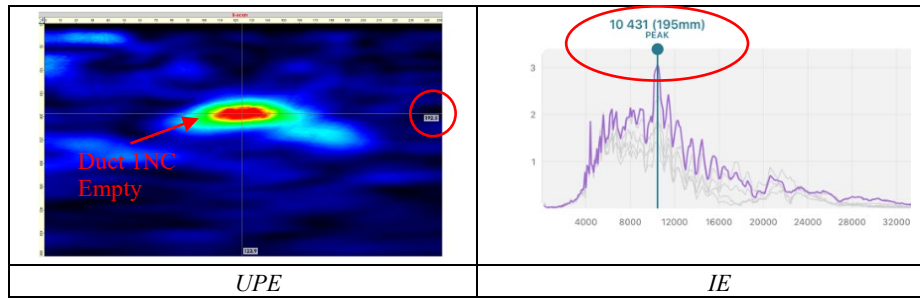
Figure 9 shows a scan of a duct with a void, 1NC. In this example the duct is placed with a cover of $T=190\text{ mm}$ and $C_p = 4140\text{ m/s}$, a void in this duct should give a frequency peak according to the following calculation:

Fig. 9. Scan in 2NA scan 67 with no presence of voids. Backwall at 400 with both UPE & IE.
