Proceedings of the 7th International Conference on Concrete Repair, Rehabilitation and Retrofitting

Assessment of SFRC Slab-on-Piles Through In-Situ Load Testing

Keywords: Full-Scale Test · SFRC · Slab-on-Piles

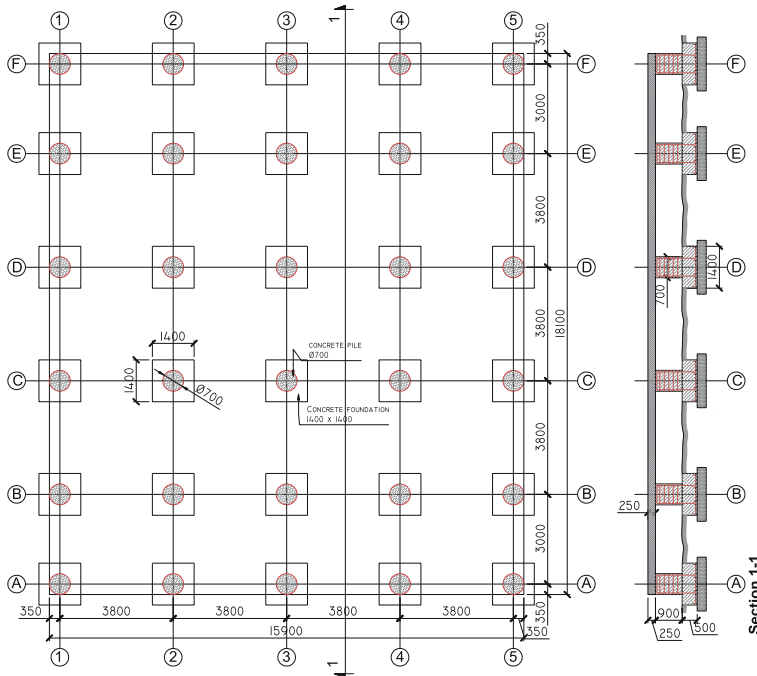
Fig. 1. General dimension of the tested slab-on-piles.

The tested slab is designed to replicate a section of a large slab-on-piles from a warehouse (Fig. 1). For practical reasons, the slab size has been limited to fewer bays compared to the original structure, resulting in a 5×4 bay configuration. Each pile has a diameter of 700 mm and supports a 250-mm-thick SFRC slab. The piles transfer vertical loads to isolated foundations cast on a well-packed gravel layer. The distance between the piles is 3.8 m.

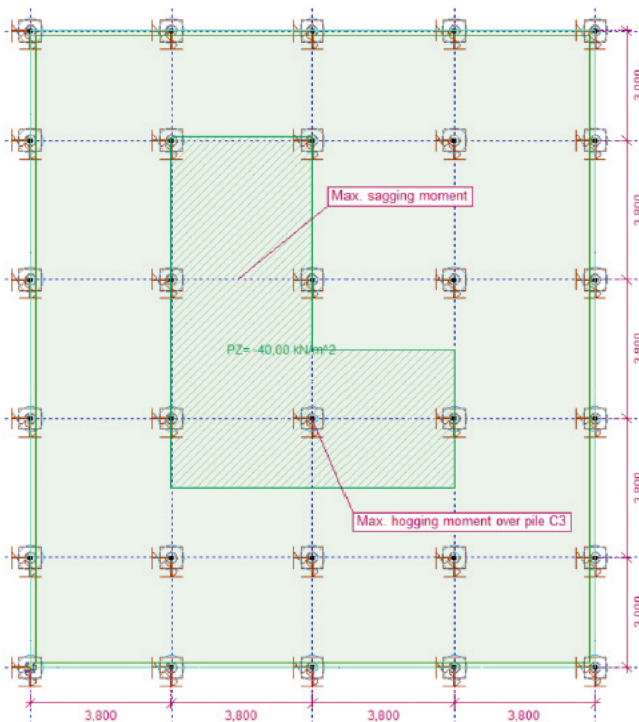
Fig. 2. FE model: geometry, load configuration and areas of maximum positive and negative bending moments.

The slab testing involved performance evaluation under both service and ultimate limit states as outlined by the Eurocode. A distributed load with a characteristic value of 40 kN/m^2 was applied to the slab. Due to practical constraints, only a limited area of the slab was loaded. This area was chosen through an iterative process using finite element (FE) analysis, which considered multiple loading arrangements to achieve maximum bending moments in the field and over supports simultaneously. The final loading arrangement is depicted in Fig. 2 (hatched area).

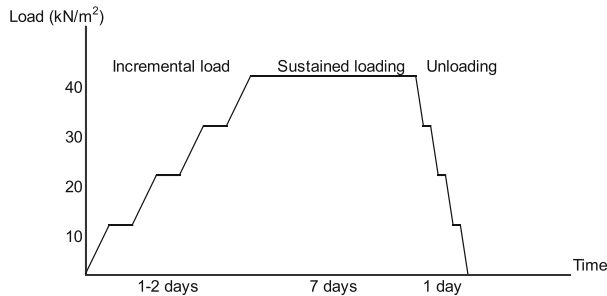
Fig. 3. Modified load sequence based on ACI 437.2-13.

The load was applied according to a predetermined schedule, with increments of 10 kN/m^2 added to the slab until the intended load level was reached. The load was then maintained for up to 7 days before being removed, as shown in Fig. 3. The testing procedure was conceptually similar for all load tests, with a few differences. For instance, in load sequence 3, the load was maintained overnight instead of 7 days and then continued up to 60 kN/m^2 (load sequence 4). In load sequence 5, the loads were gradually applied until failure was achieved.

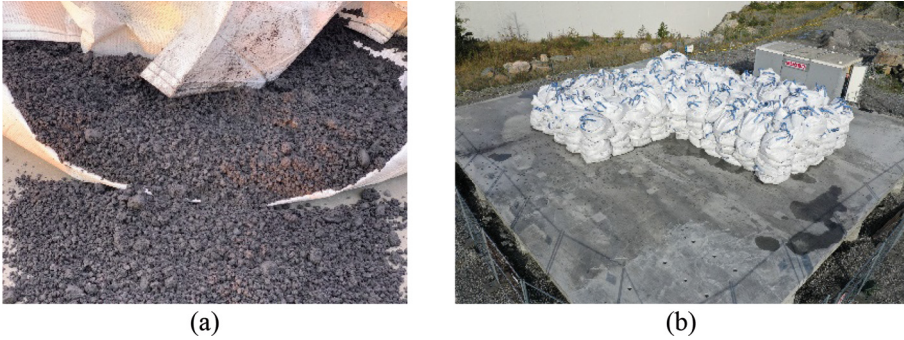
Fig. 4. Loaded slab: (a) loading material; and (b) placement of the loads on the slab.

To simulate distributed loads as accurately as possible, the load material used was fines (steel slag, a by-product of steelmaking) with a density of 3500 kg/m^3 , as shown in Fig. 4a. This material was chosen due to its high density and ability to conform to the

surface. Additionally, the bags do not interlock, and the magnetite gravel molds itself, preventing a bridging effect. This ensures that the intended load height is lower while maintaining an evenly distributed load, as illustrated in Fig. 4b. The load was applied using large bags with a bottom area of 0.9×0.9 m. Each bag was individually weighed, and the weight was marked on the bag.

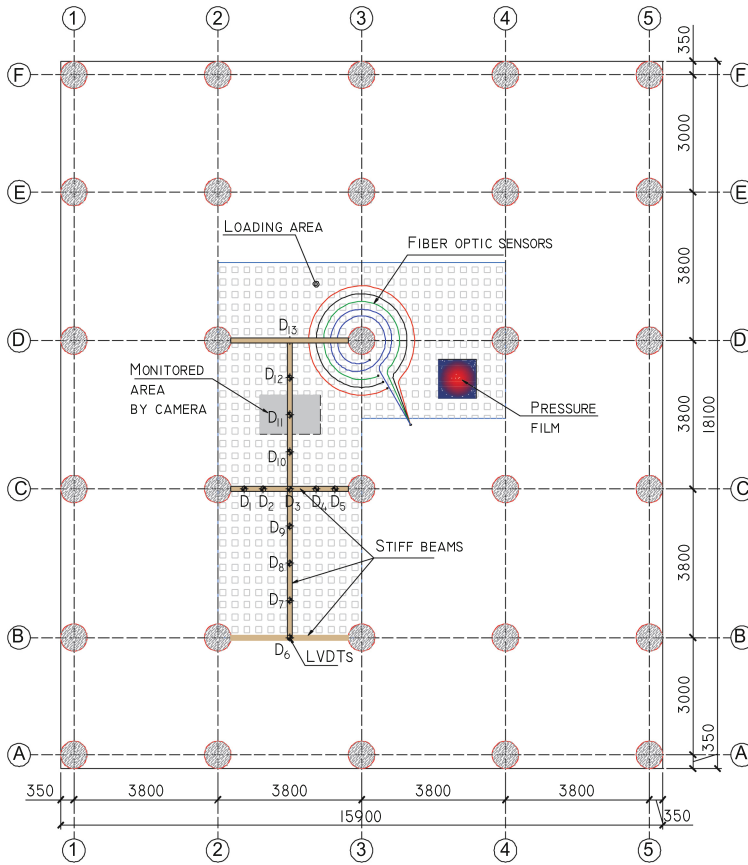
Fig. 5. Instrumentation plan.

The FE model was used as a rough guide to position the instrumentation where maximum responses were expected. The sensor locations for monitoring the slab's

response during load testing are shown in Fig. 5. Due to space limitations, only selected measurements are reported.

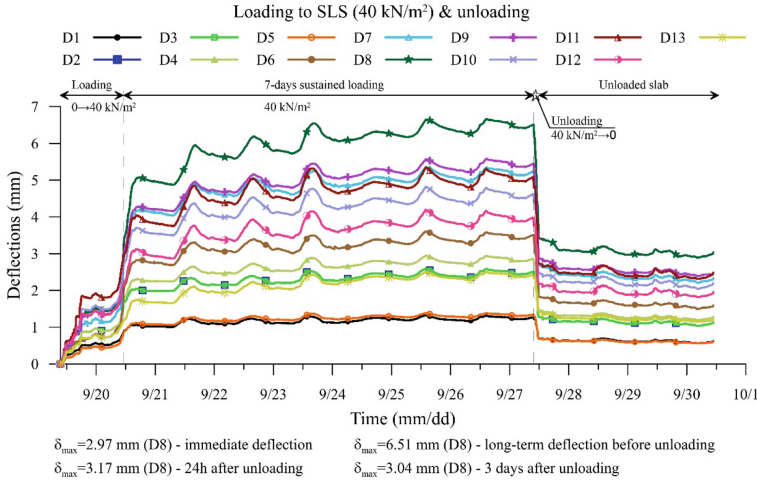
Fig. 6. Deflection under the serviceability limit state, SLS – 40 kN/m²

Deflection at the serviceability limit state (SLS) of 40 kN/m^2 is shown in Fig. 6. Distinct phases can be observed. In Phase 1, at approximately 2 mm deformation, cracking occurs, rapidly increasing the deformation to around 5.0 mm. After about 4 days, the deformation levels off, reaching a maximum of about 6.5 mm after 7 days. The largest deformation was observed at LVDT sensor D8. Upon unloading, residual deformation was approximately 3.17 mm, reducing to 3.04 mm after a further 3 days.

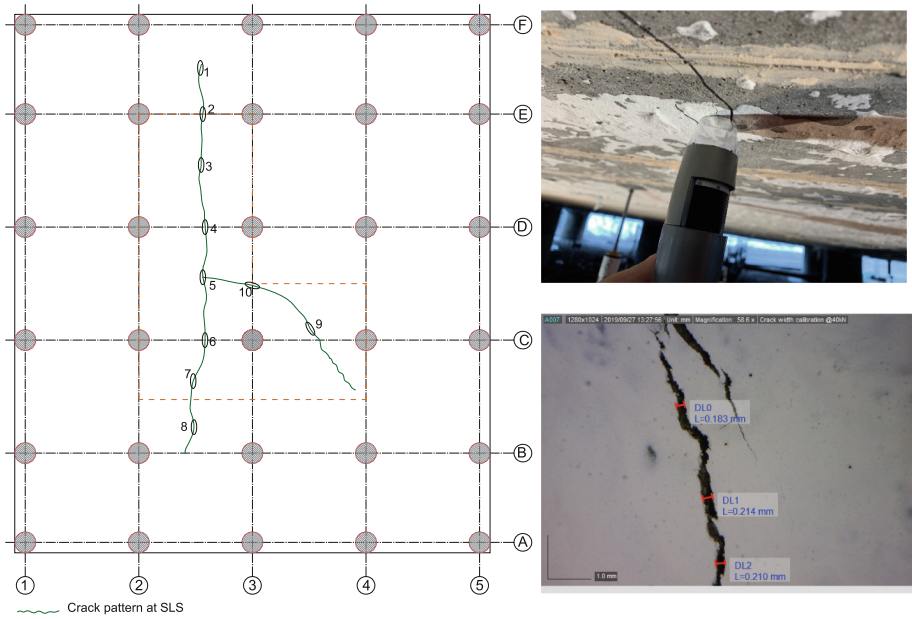
Fig. 7. Crack pattern and crack widths after loading at SLS – 40 kN/m^2

Figure 7 illustrates the crack pattern at SLS. Mapping was done visually by hand on the lower side and with drone support on the upper side. Regions where crack widths and depths were investigated are shown in Fig. 7. On the bottom, a thin crack was noted, with widths ranging from 0.11 mm in region 8 to 0.41 mm in regions 3 and 10. On the top surface, a small, barely visible crack was observed above pile C3, with a width of about 0.08 mm. The crack widths were measured at the end of the 7-day sustained load period, just before unloading.

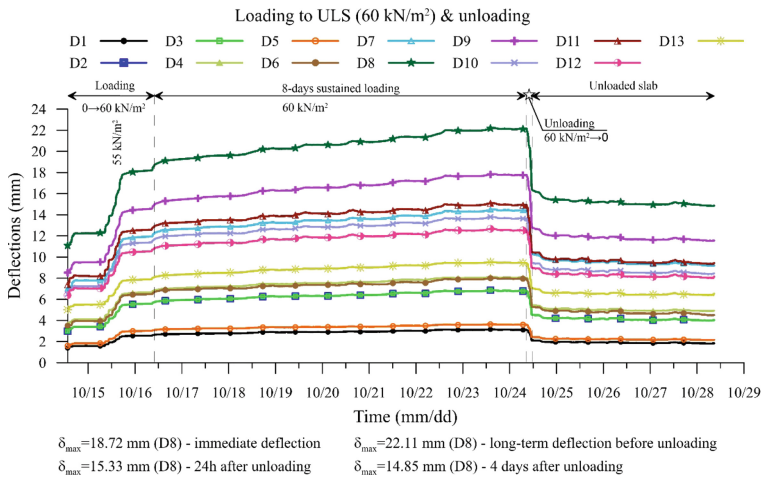
Fig. 8. Deflection under the ultimate limit state, ULS – 60 kN/m^2

Deflection at the ultimate limit state (ULS) of 60 kN/m² is shown in Fig. 8. Deformation increased to approximately 18.0 mm when the load reached 55 kN/m², which was then maintained for a day before being increased to 60 kN/m². At the ULS load level, deformations increased to approximately 19 mm. After the load was applied for less than a week, the deformation reached approximately 22.1 mm. The deformation leveled off towards the end of the loading sequence.

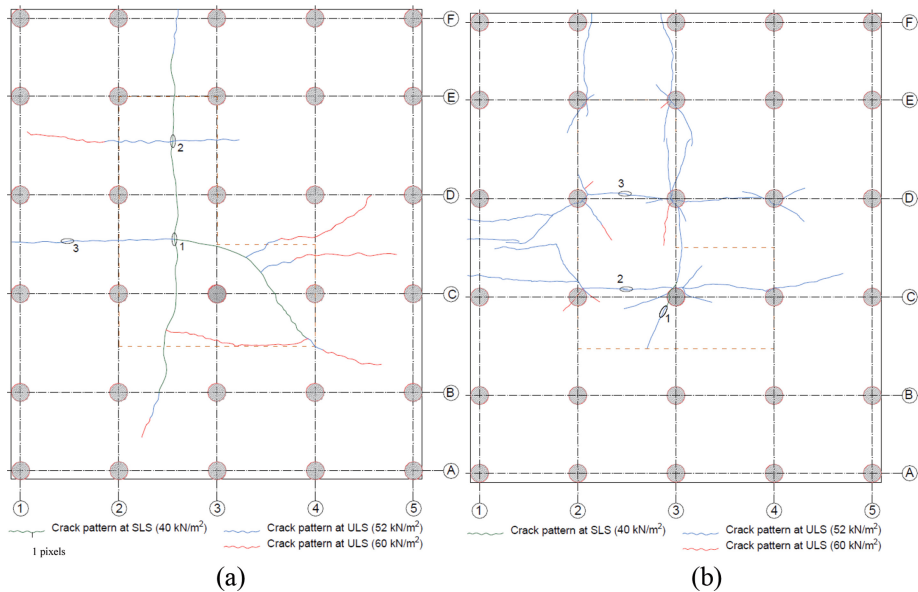
Fig. 9. Crack pattern after each loading sequence: (a) bottom surface; and (b) top surface.

Although cracking is relevant for the service limit state, it was also monitored at the ULS. Once the main crack appeared at the SLS, an LVDT was mounted over the crack to track its progression. At the ULS, the crack grew to approximately 2.20 mm for crack 1 and approximately 2.25 mm for crack 2. The crack pattern developed throughout all loading stages is shown in Fig. 9.

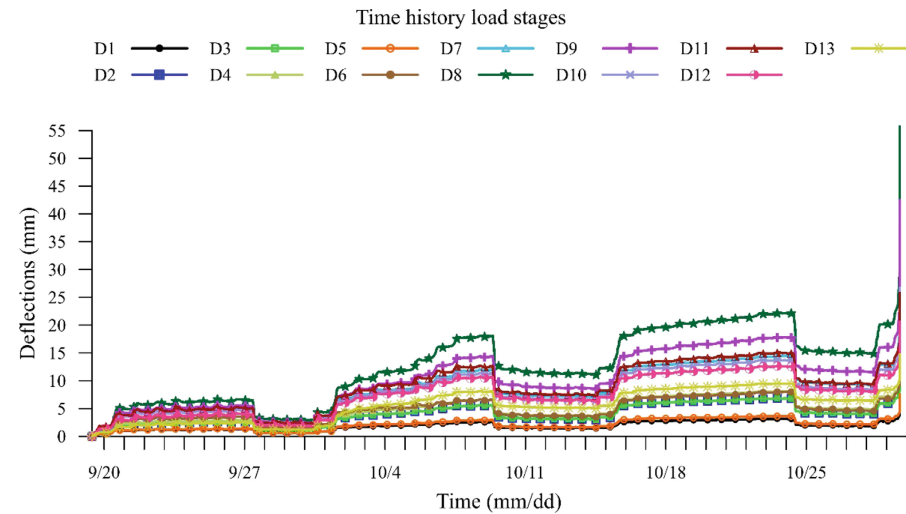
Fig. 10. Deflection during all load sequences, from SLS to ULS and up to failure, 40 – 77.8 kN/m²

The final loading sequence aims to determine the ultimate load-carrying capacity of the slab. Figure 10 illustrates the deformation diagram for all load sequences, including the load leading to failure. Observing this diagram, we can identify two stabilization phases of the plate. The first occurs at the service load of 40 kN/m², where the plate exhibits very stable behavior after initial cracking. The second stabilization phase occurs at approximately 55–60 kN/m², where the behavior remains stable, with a plateau of around 20 mm deformation along the long direction of the plate. At the point of failure (Fig. 11), we observe an increase in deformation without a corresponding increase in

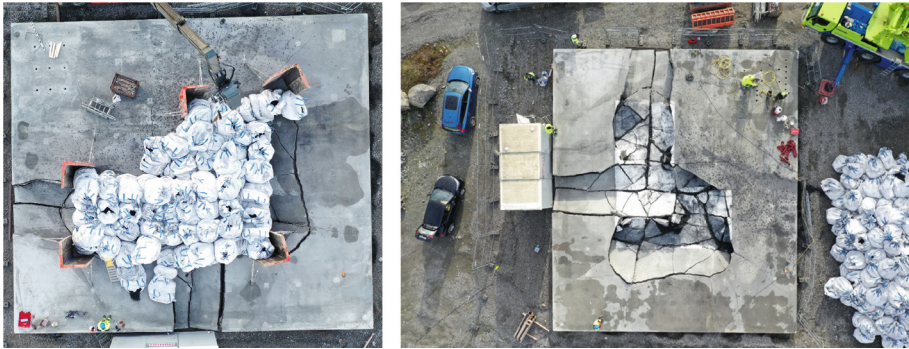
Fig. 11. Photo after failure – before and after removal of the loading bags.

load. The measurement ceases at approximately 55 mm relative to the original position due to the rapid failure process, which was load-controlled. As a result, no further deformations are recorded as the sensors were destroyed by the failed slab. The slab failed at 77.8 kN/m^2 , including its own weight of approximately 6 kN/m^2 , resulting in a total failure load of about 83.4 kN/m^2 .
