Proceedings of the 7th International Conference on Concrete Repair, Rehabilitation and Retrofitting

Non-destructive Testing of a Post-tensioned Concrete Road Bridge in Norway

Abstract. The Herøysunds bridge on the west-coast in Nordland Fylke in Norway had undergone concrete repair works with focus on reinforcement corrosion. During these actions, it was discovered that the tendon ducts had loss of injection.

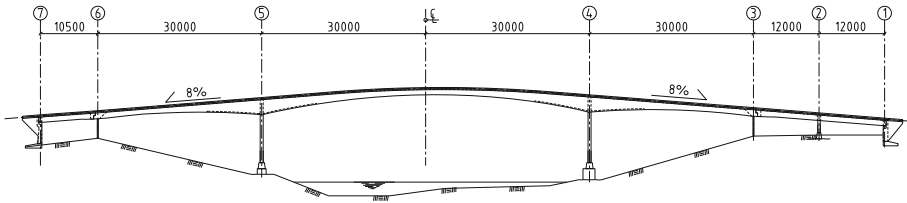
Herøysundet Bridge is a beam bridge, constructed on-site with varying height (Fig. 1). The bridge has 6 spans consisting of 5 pillars and two abutments. The total length of the bridge is 154 m, it has one traffic lane, as well as sidewalks on both sides, and the largest overall width is 5.30 m. The largest span, which is the navigational channel, is located in span 4 and has a length of 60 m. Pillars and abutments are founded on rock.

Fig. 1. Herøysund Bridge – elevation

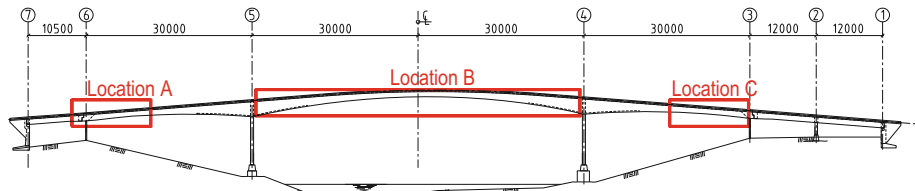
The testing sites for the Herøysund Bridge have been prearranged in consultation with the Norwegian Road Administration and Nordland County. The objective is to conduct Non-Destructive Testing (NDT) on all girders where access to tendons was feasible. It should be noted that tendons situated in the concrete deck have not undergone inspection. All test locations are illustrated in Fig. 2 together with a more detailed description of section A in Fig. 3. Also, the original section is presented in this figure. However, in this paper only location A, and only the North beam is going to be discussed. The approach is then similar for all other locations. In the next section the NDT (Non-Destructive-Test) approach is presented.

Fig. 2. Testing locations

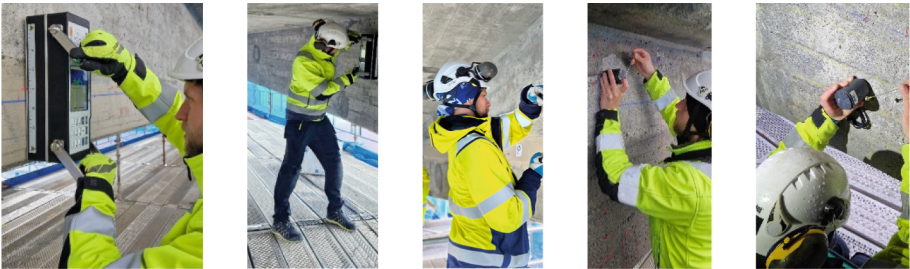
The main purpose of the investigation conducted at Herøy Bridge was to verify the integrity of the grouting along the post tensioned tendons. Non-destructive test methods have been used to be able to check for defects. The measurements were repeated as vertical scans in the same locations as the original drawing, with this approach, the placements could be compared for the north beam in location 6, see Fig. 4. MIRA equipment has been used in all cases to evaluate the condition of grouted post-tensioning ducts in the webs. B-scans (2D images) were collected every 10 cm along the ducts, see Fig. 5. In total, around 3000 B-scans were collected throughout the bridge. The B-scans reflects the cross-section (perpendicular to the test surface) while the C-scans are obtained by combining multiple B-scans – thus, showing the reflecting interfaces on a plane parallel to the test surface. For example, tendons are shown as big dots on a B-scan together with their depth (“concrete cover”) as well as the back-wall (thickness of the scanned element). On the C-scan the tendon ducts are shown as continuous lines. The lines may have a green-yellow color and indicates lower amplitude reflections from the steel tendons – meaning the duct is fully grouted. If the lines are displayed as red color, this indicates strong reflections from a discontinuity in material properties. Areas with strong interference that is characteristic of an air void will be further inspected with impact-echo instrument, see also Fig. 5.

Fig. 5. Inspecting grouting conditions with MIRA and Impact Echo
