Non-destructive testing of a post-tensioned concrete road bridge in Norway

Abstract. The Herøysunds bridge on the west-coast in Nordland Fylke in Norway had undergone concrete repair works with focus on reinforcement corrosion. During these actions, it was discovered that the tendon ducts had loss of injection.

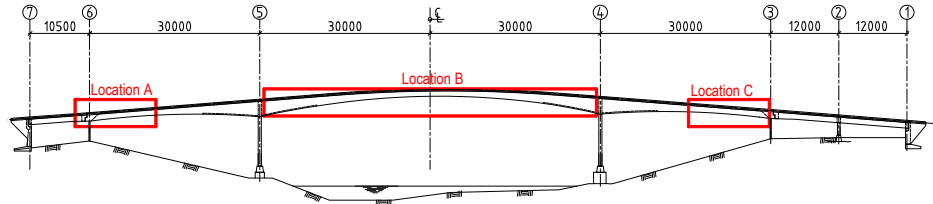
Fig. 2. Testing locations

The testing sites for the Herøysund Bridge have been prearranged in consultation with the Norwegian Road Administration and Nordland County. The objective is to conduct Non-Destructive Testing (NDT) on all girders where access to tendons was feasible. It should be noted that tendons situated in the concrete deck have not undergone inspection. All test locations are illustrated in figure 2 together with a more detailed description of section A in figure 3. Also, the original section is presented in this figure. However, in this paper only location A, and only the North beam is going to be discussed. The approach is then similar for all other locations. In the next section the NDT (Non-Destructive-Test) approach is presented.
